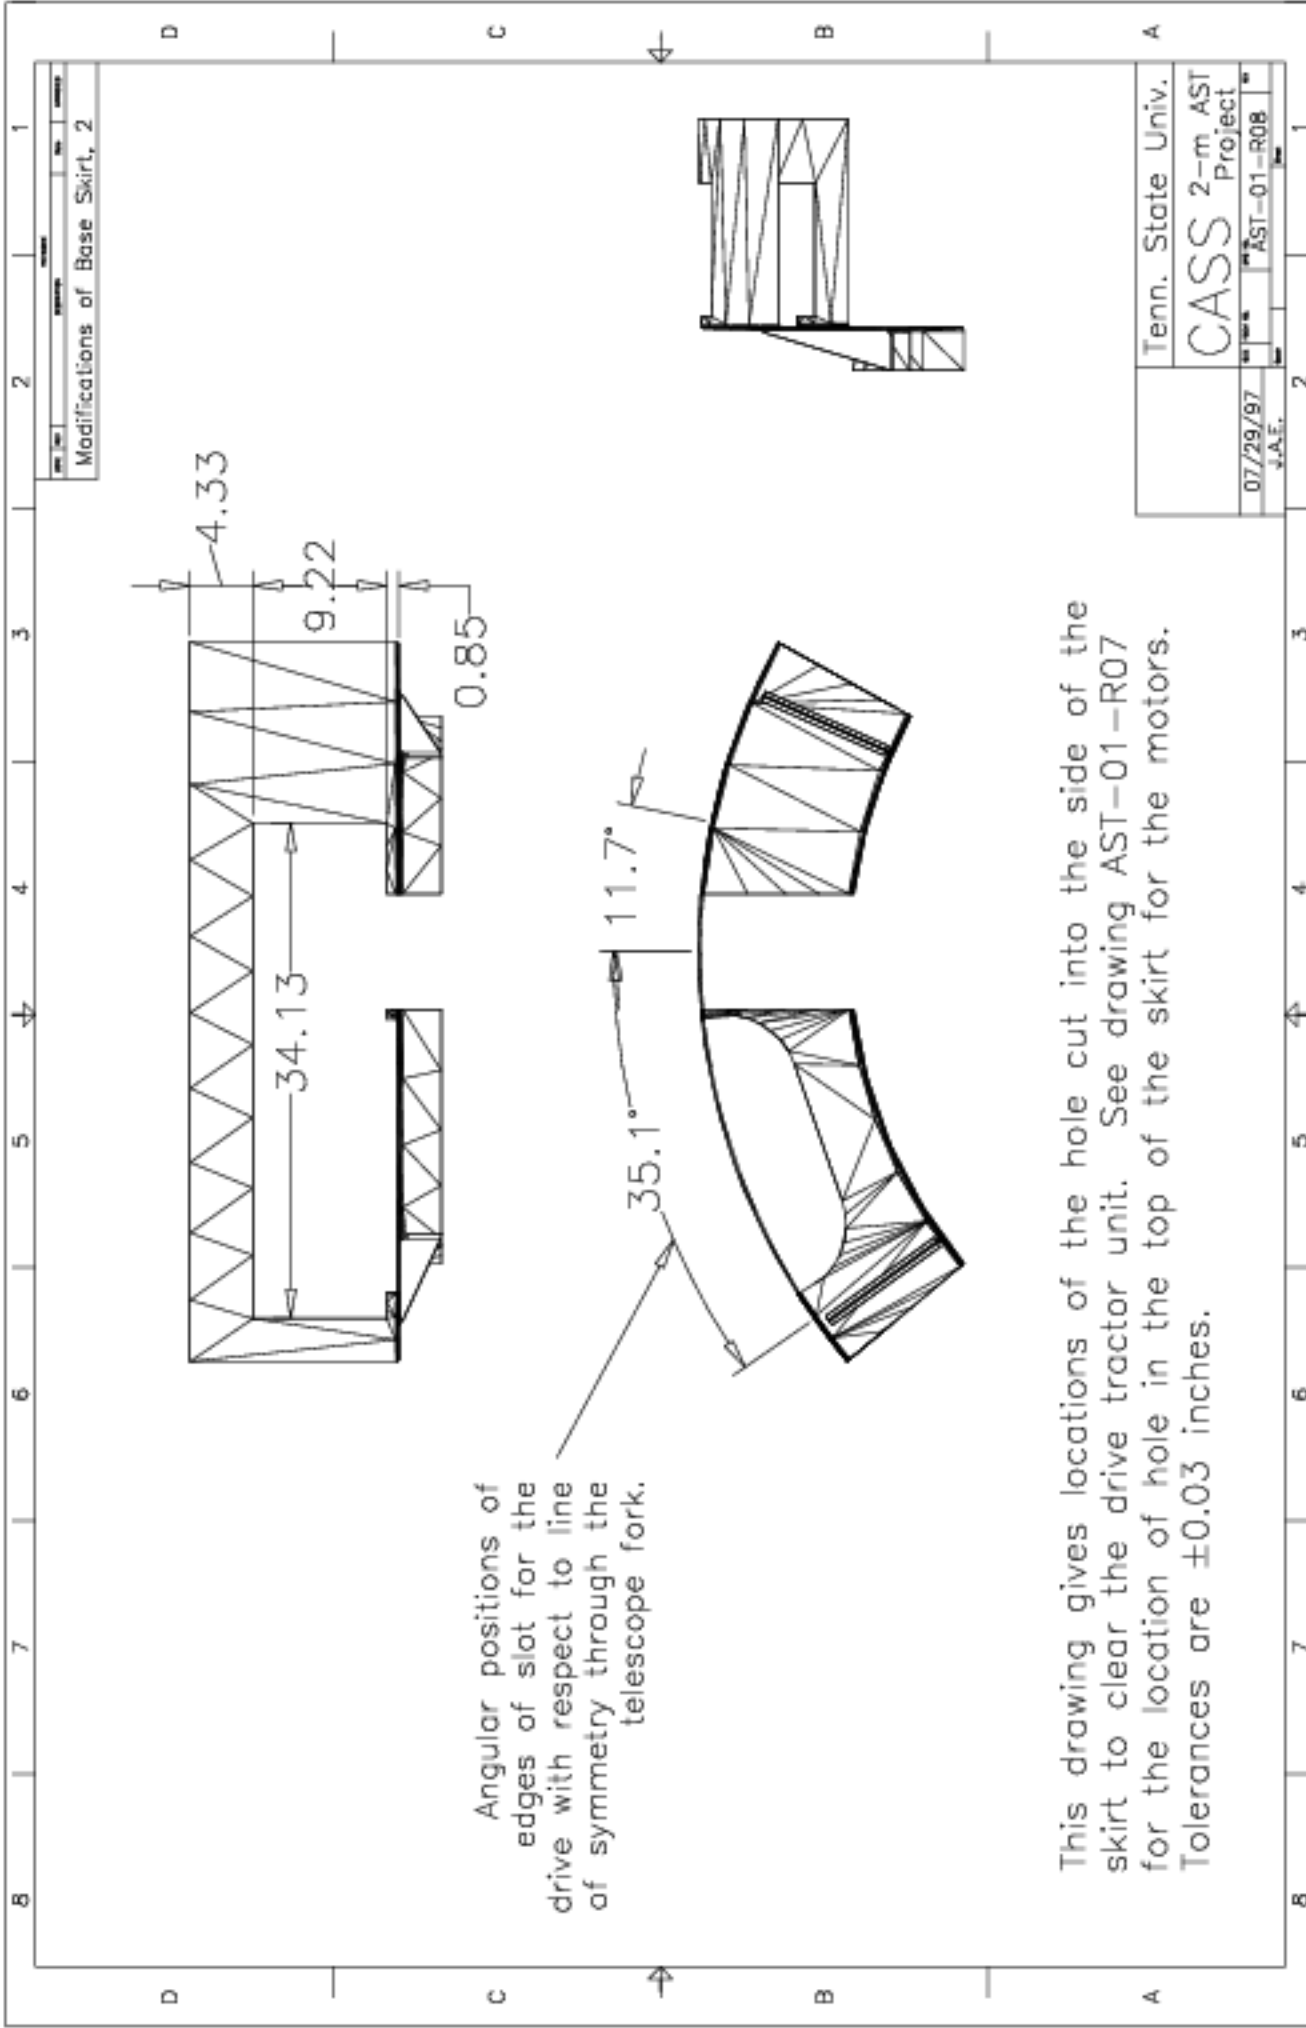
This drawing gives locations of the hole cut into the side of the skirt to clear the drive tractor unit. See drawing AST-01-R07 for the location of hole in the top of the skirt for the motors. Tolerances are ± 0.03 inches.
